**State of California  
The Resources Agency  
DEPARTMENT OF WATER RESOURCES  
DIVISION OF FLOOD MANAGEMENT**

**2004  
PROJECT STRUCTURE REPORT**

**INSPECTION OF  
FLOOD CONTROL STRUCTURES ON THE  
SACRAMENTO AND SAN JOAQUIN RIVERS  
AND THEIR TRIBUTARIES**

**Prepared By The  
Flood Operations Branch  
Flood Project Inspection Section**

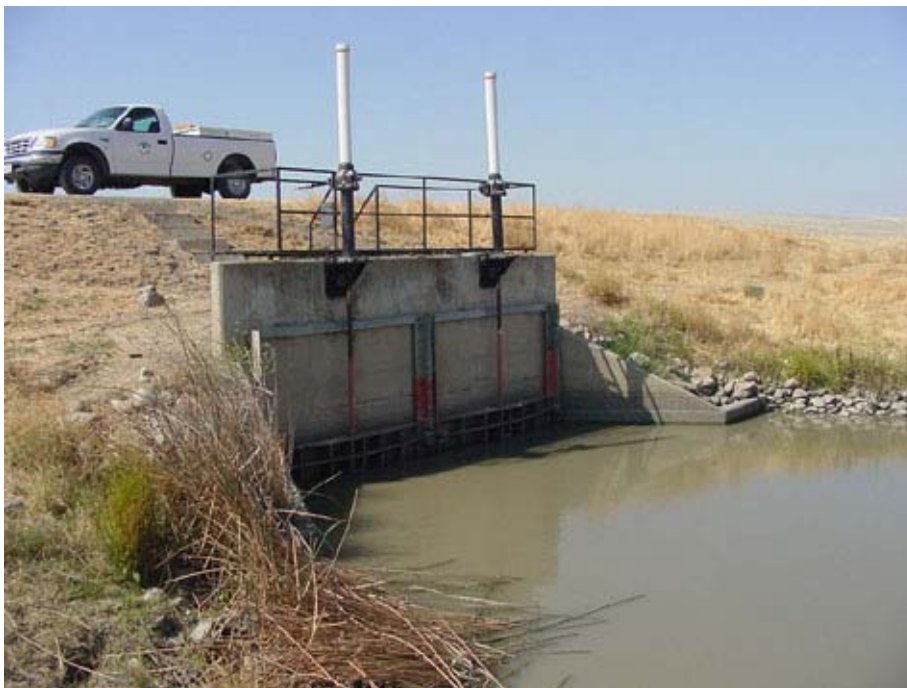
**View of the two 72 inch slide gates at the intake side of the structure.**

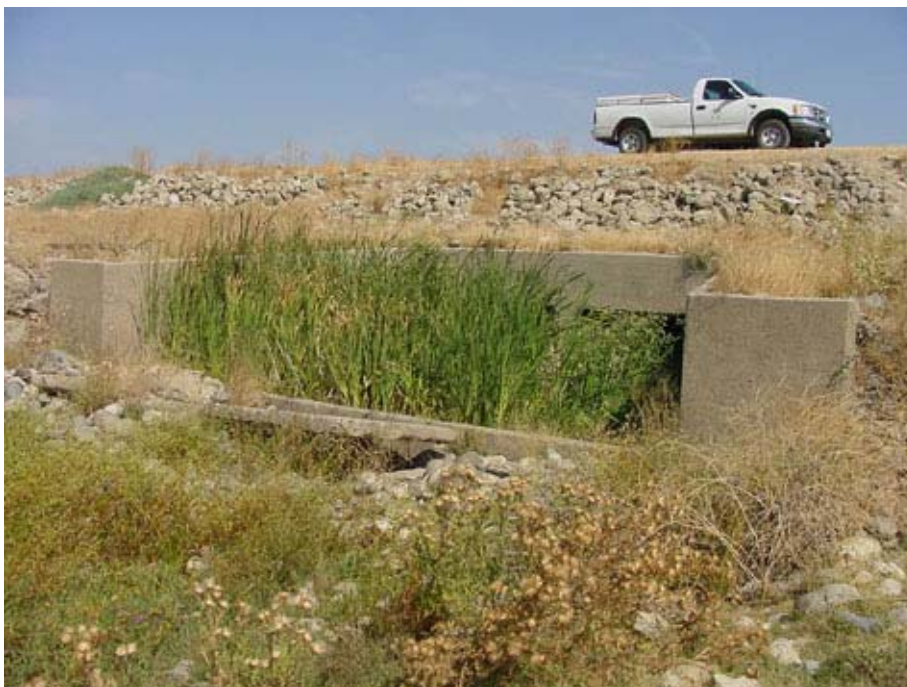
**View of the discharge side of the structure into the Eastside Bypass.**

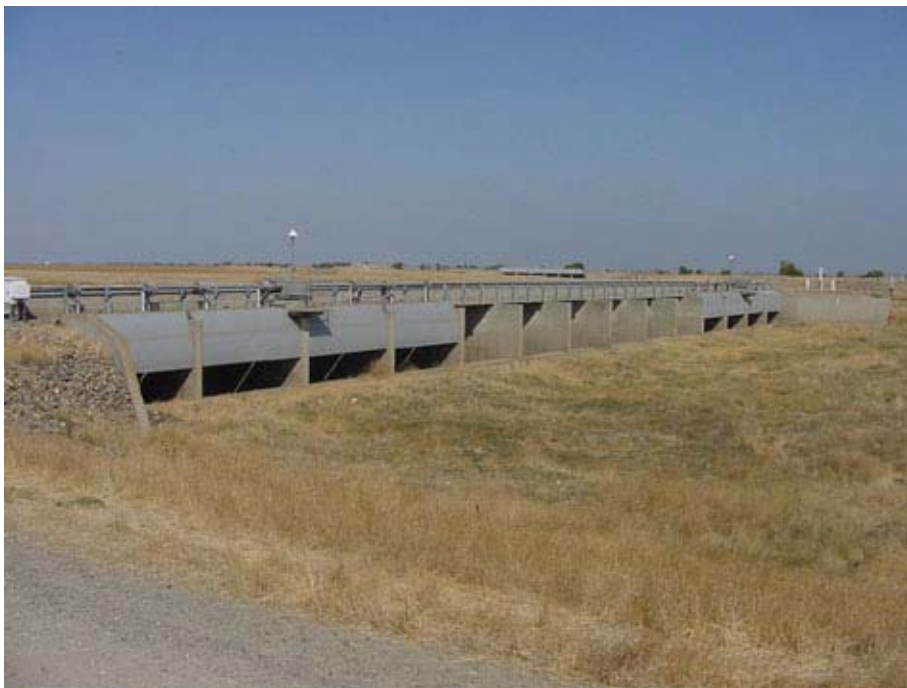
**The upstream side of the structure.**

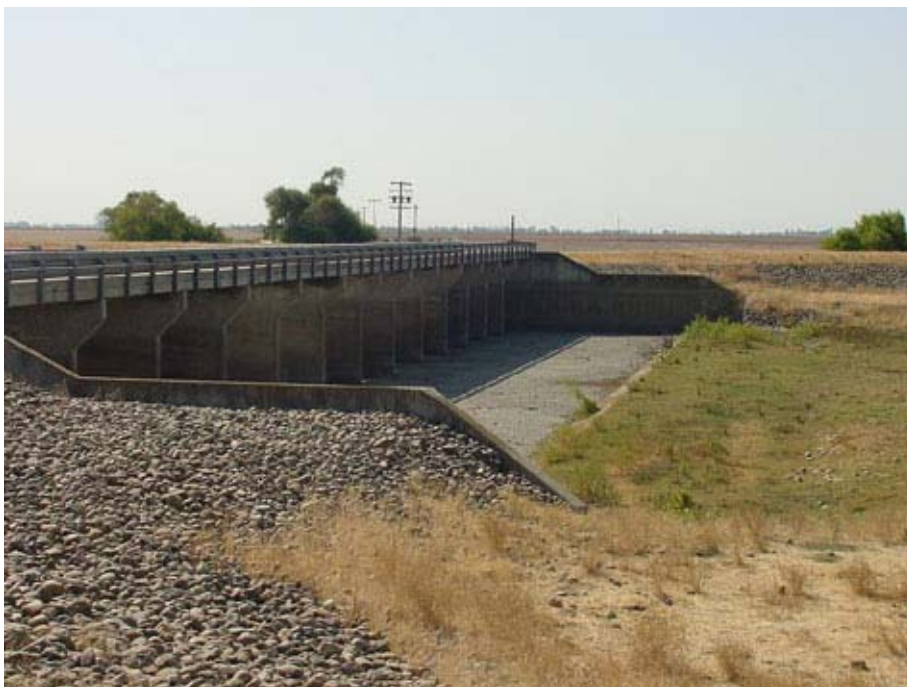
**The downstream side of the structure.**

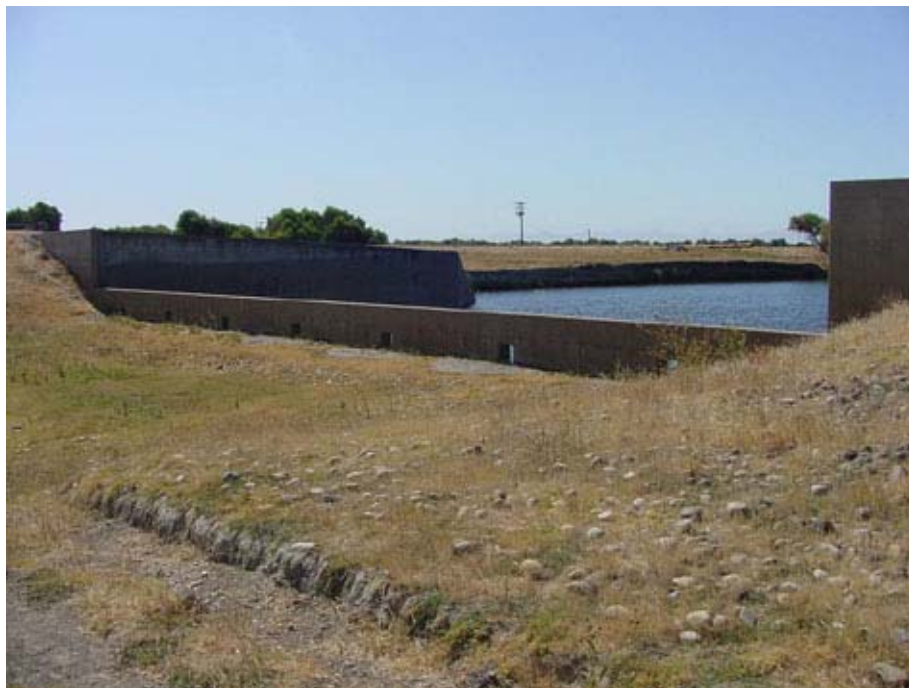
**The upstream side of the structure.**

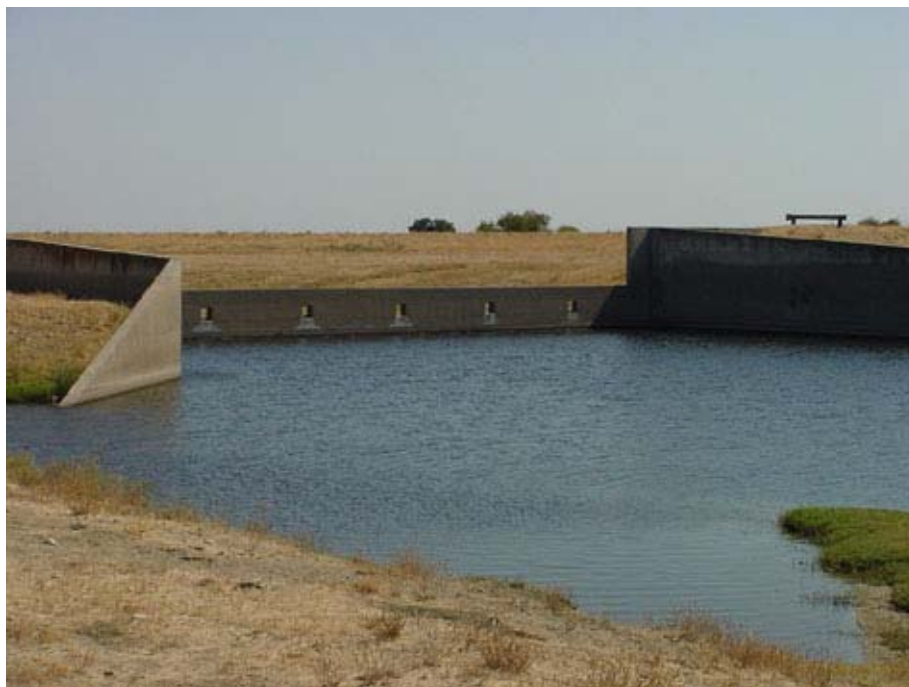
**The downstream side of the structure .**

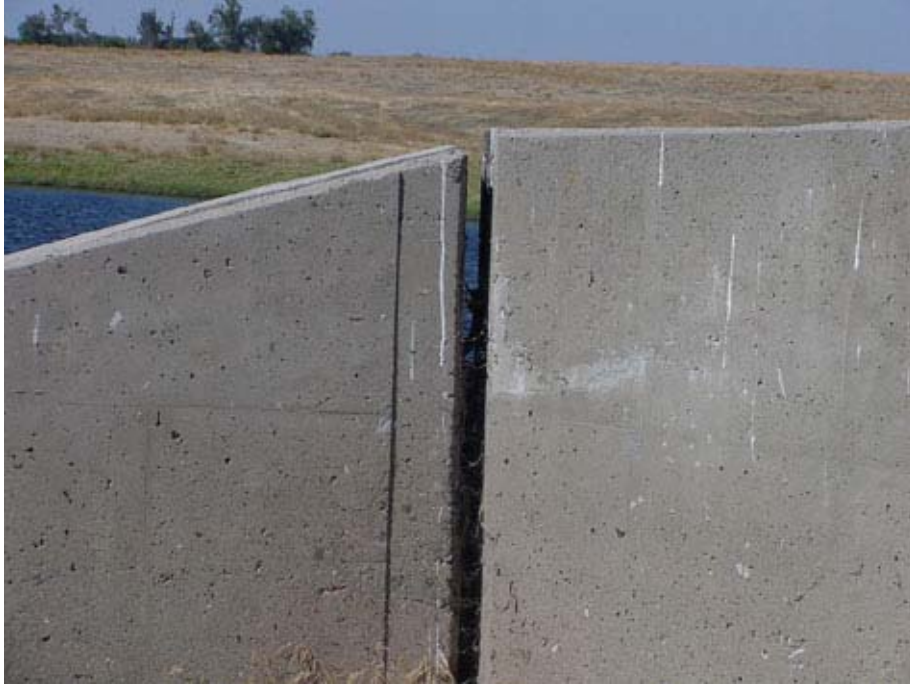
1. Condition of concrete drop structure, stilling basin, and velocity dissipaters.
  - a. Good.
2. Condition of concrete abutments and wing walls.
  - a. Left wing wall has 3 inch separation at the joint but otherwise it is in excellent condition.
3. Condition of revetment.
  - a. Good.
4. Accumulation of trash and debris around the structure or in the channel.
  - a. None.
5. Vegetation around the structure or in the channel.
  - a. None.
6. Comments:
  - a. Good maintenance.

**View of the left bank wing wall and the 3 inch joint separation.**

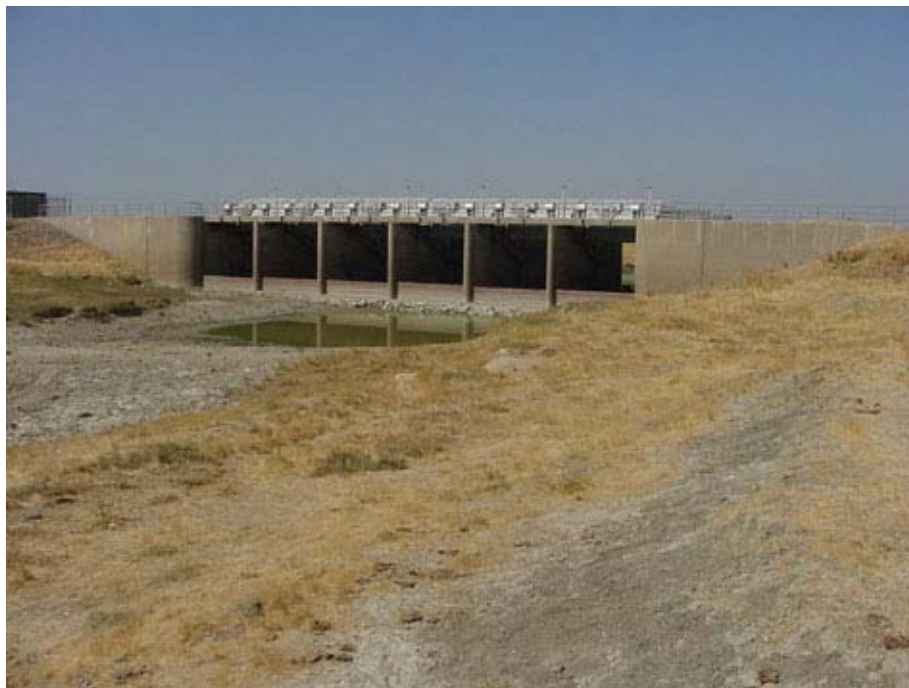
**The upstream side of the structure.**

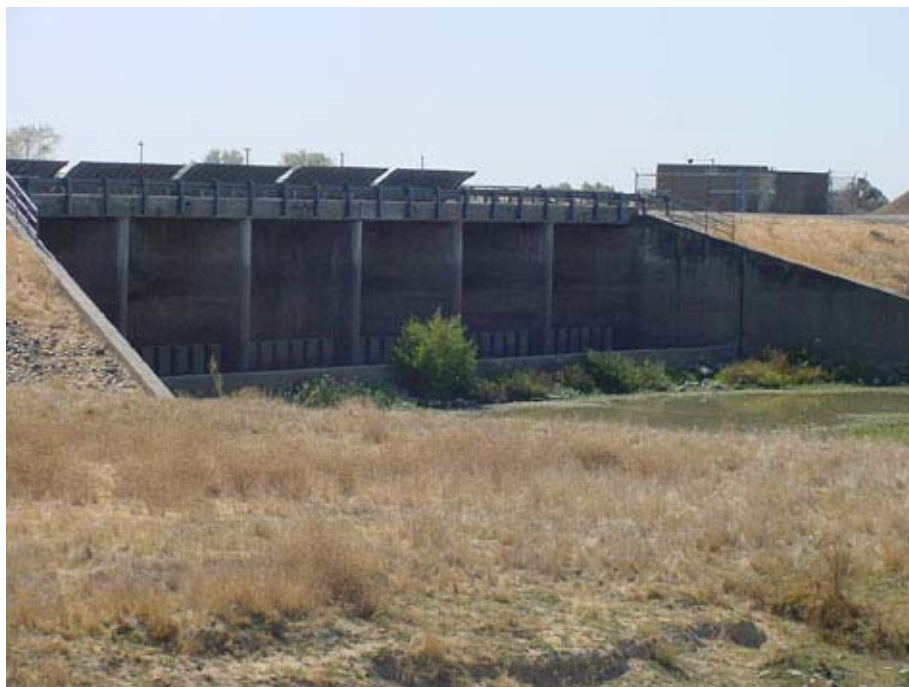
**The downstream side of the structure.**

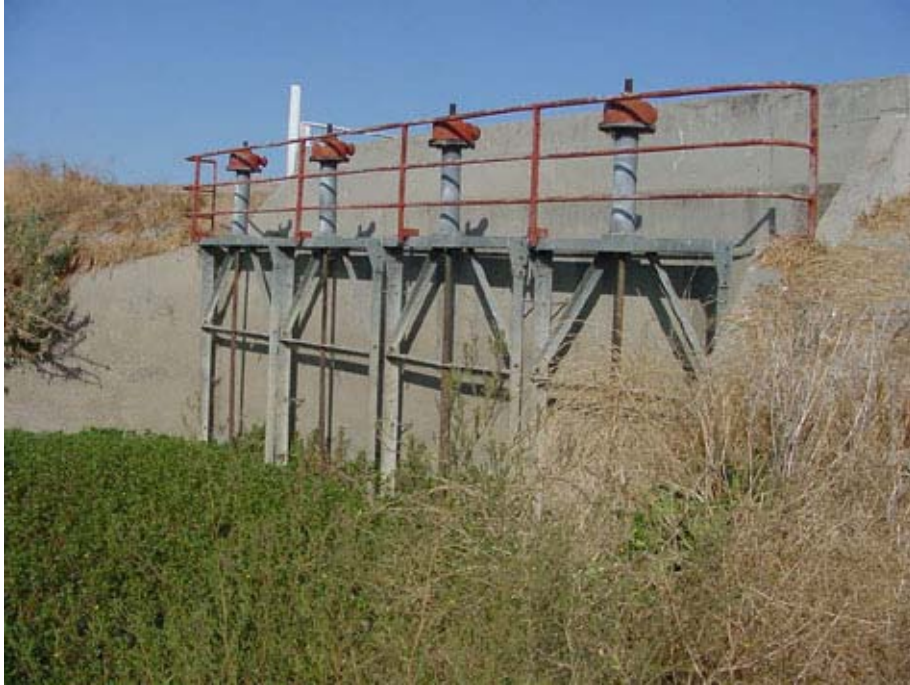
**View of the control gates at the intake of the structure.**

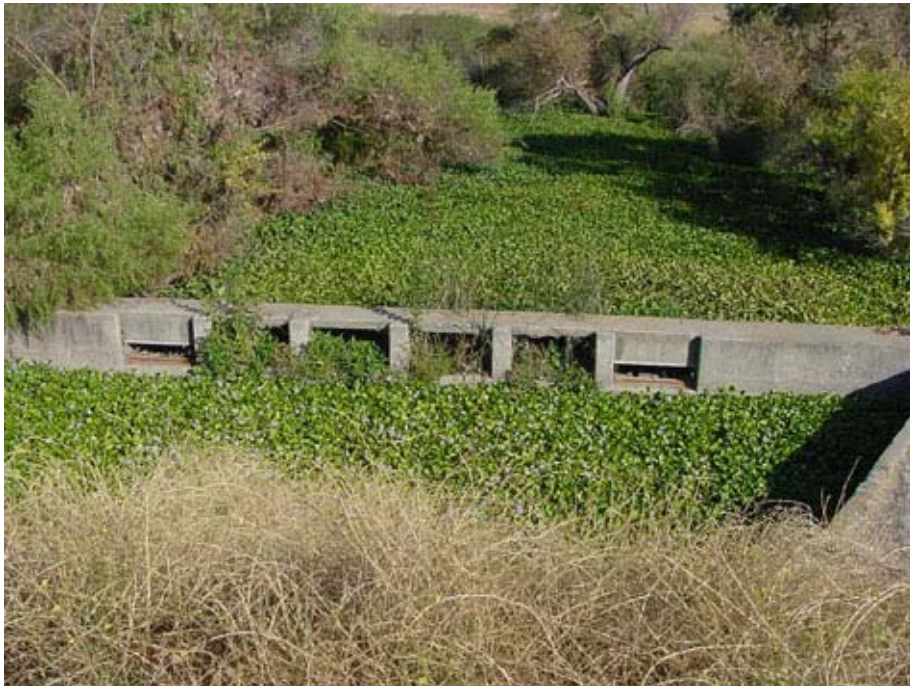
**The outlet channel.**

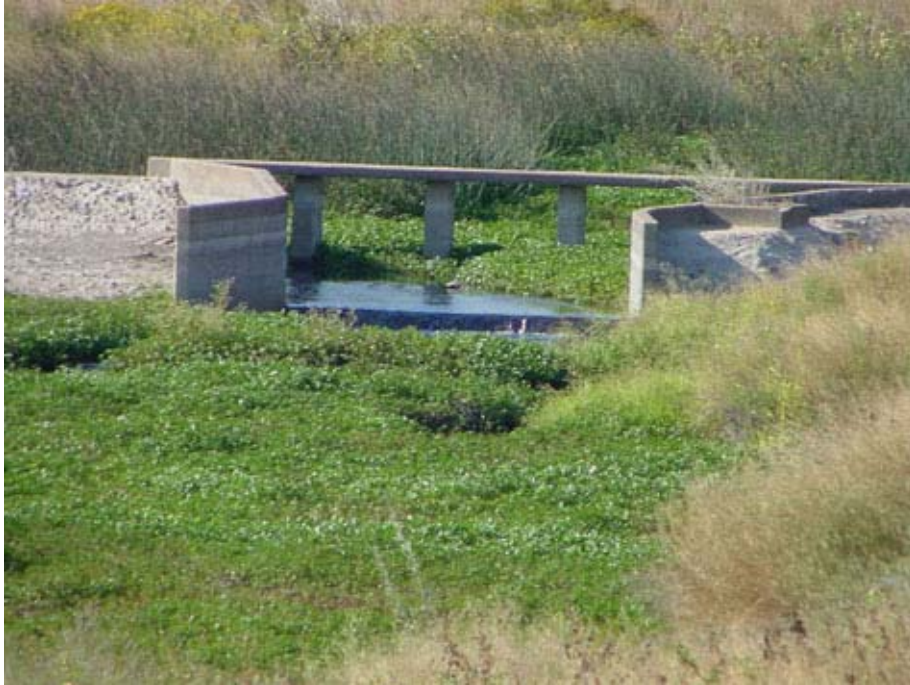
**Upstream at the Sand Slough structure  
from the Washington street bridge.**

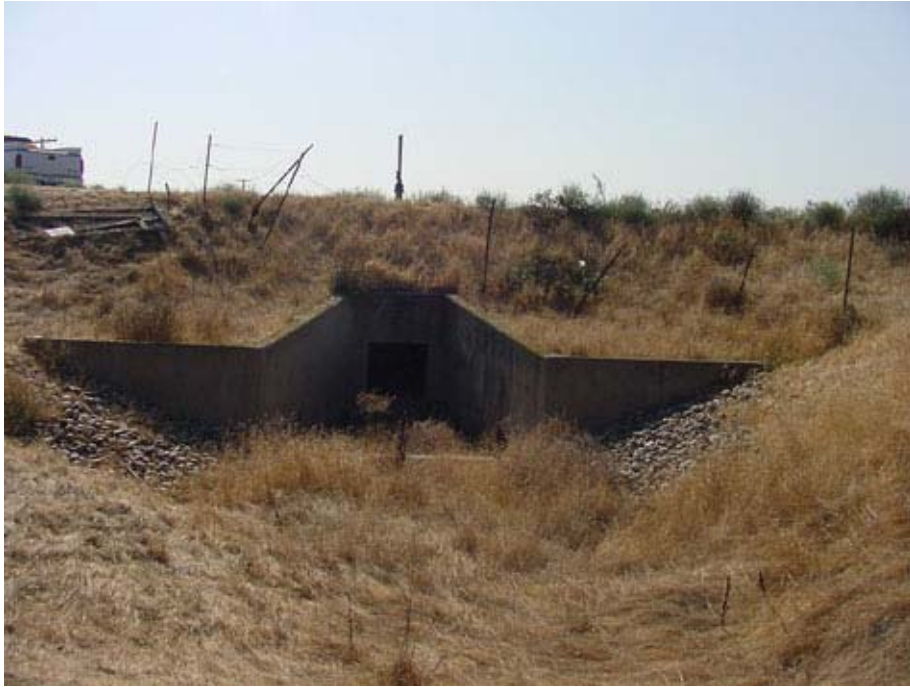
**The intake side of the structure.**

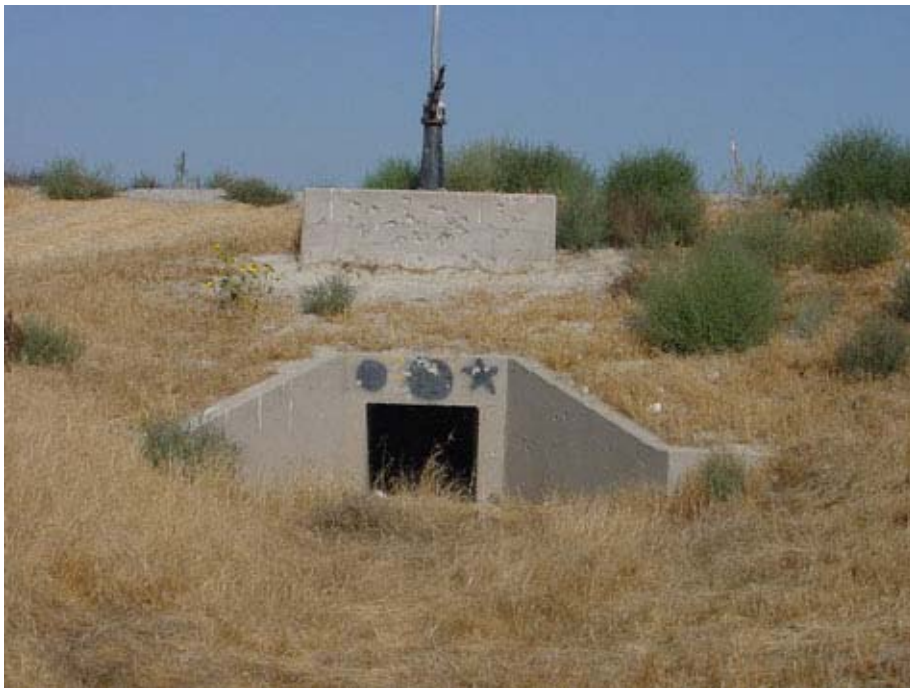
**The discharge side of the structure and the control mechanism.**

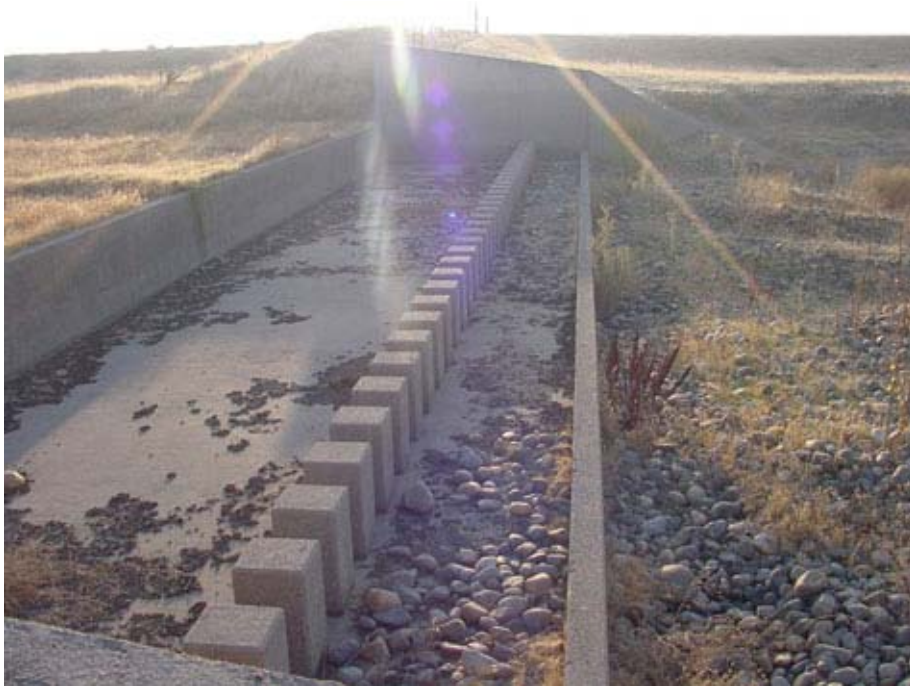
**The abutments, stilling well and velocity dissipaters.**

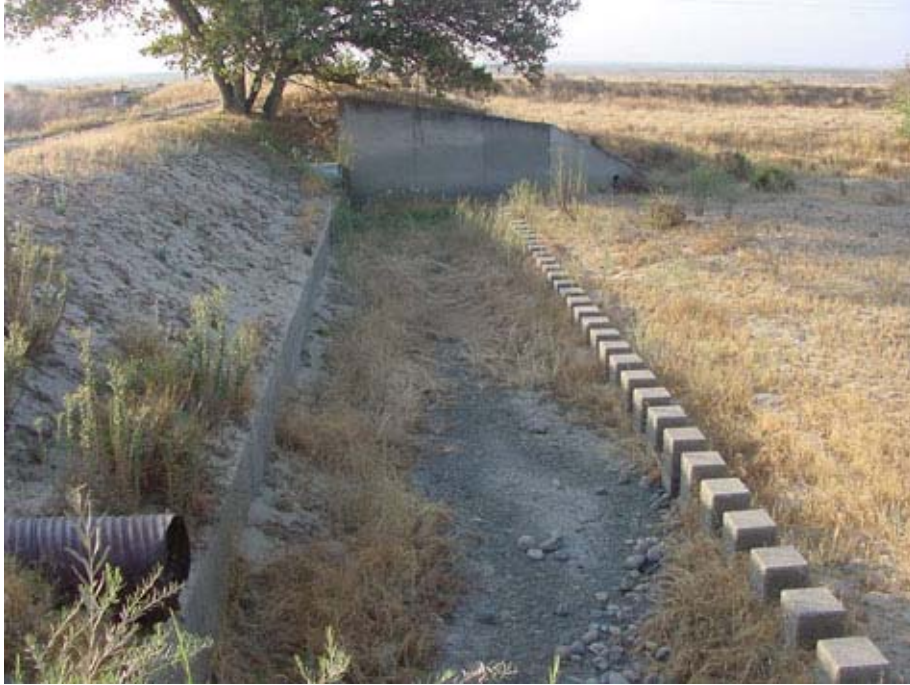
- 1. Condition of concrete drop structure, stilling basin, and velocity dissipaters.**
  - a. What can be seen is in good condition, but a seasonal sand dam is in place backing up water for irrigation purposes on the upstream side.**
- 2. Condition of concrete abutment wing walls.**
  - a. Good.**
- 3. Condition of revetment.**
  - a. Good.**
- 4. Accumulation of trash and debris around the structure or in the channel.**
  - a. None.**
- 5. Vegetation around the structure or in the channel.**
  - a. Bamboo growing along right wing wall.**
- 6. Comments:**
  - a. The seasonal sand dam on the upstream side is for irrigation purposes and can be easily breached or washed out in the event of high water.**
  - b. Remove bamboo.**

**The downstream side of the drop structure and the seasonal sand dam.**

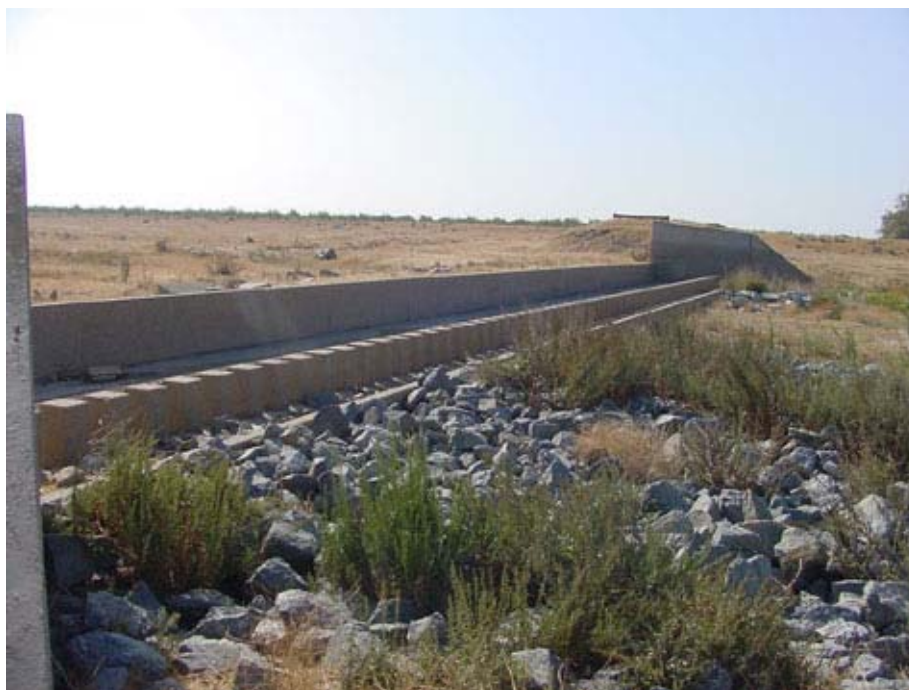
**Overview of the stilling basin and the velocity dissipaters.**

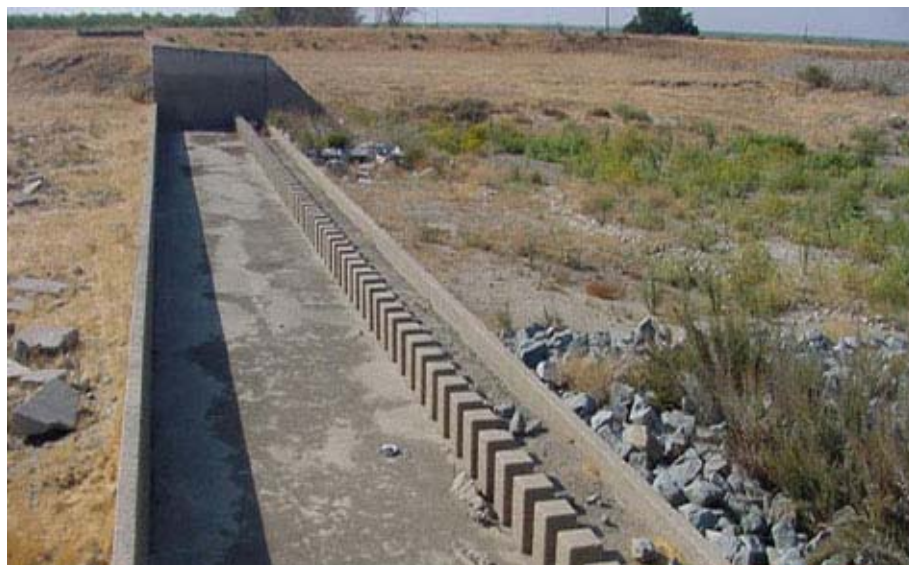
**Top view of the stilling basin and the velocity dissipaters.**

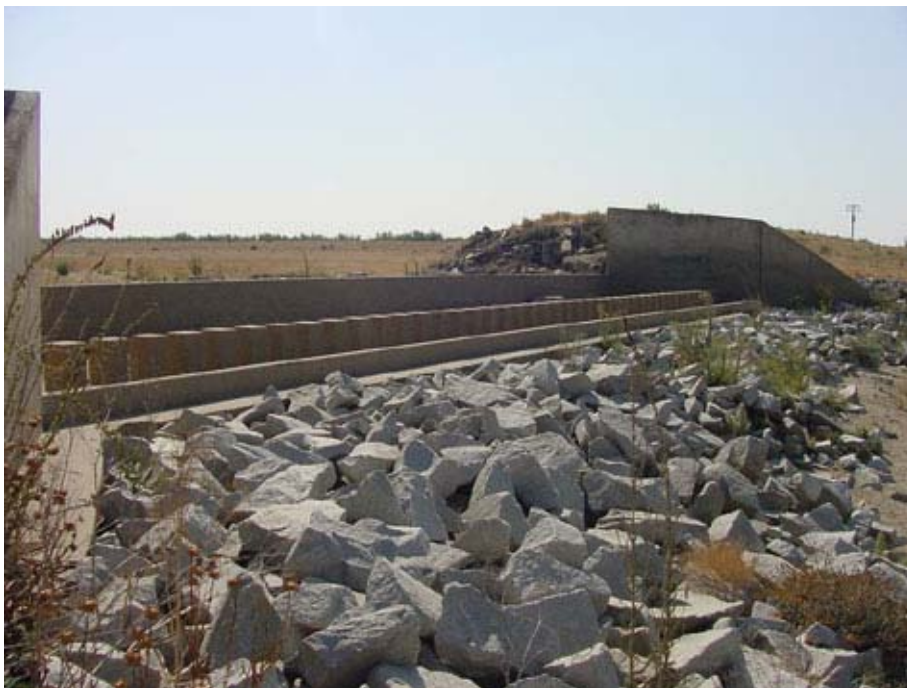
**Overview of the stilling basin and the velocity dissipaters.**

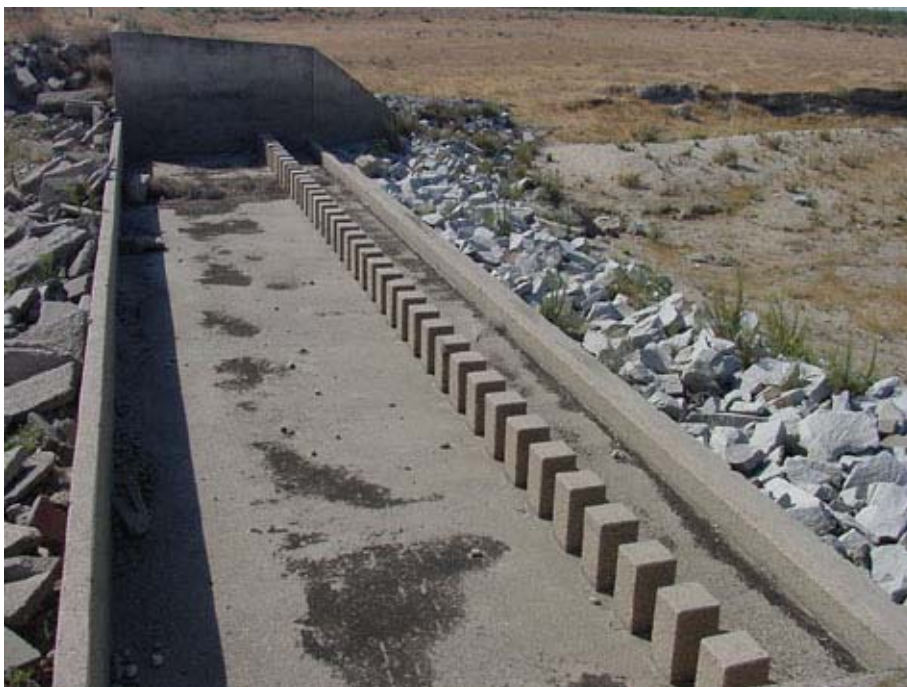
**Top view of the stilling basin and the velocity dissipaters.**

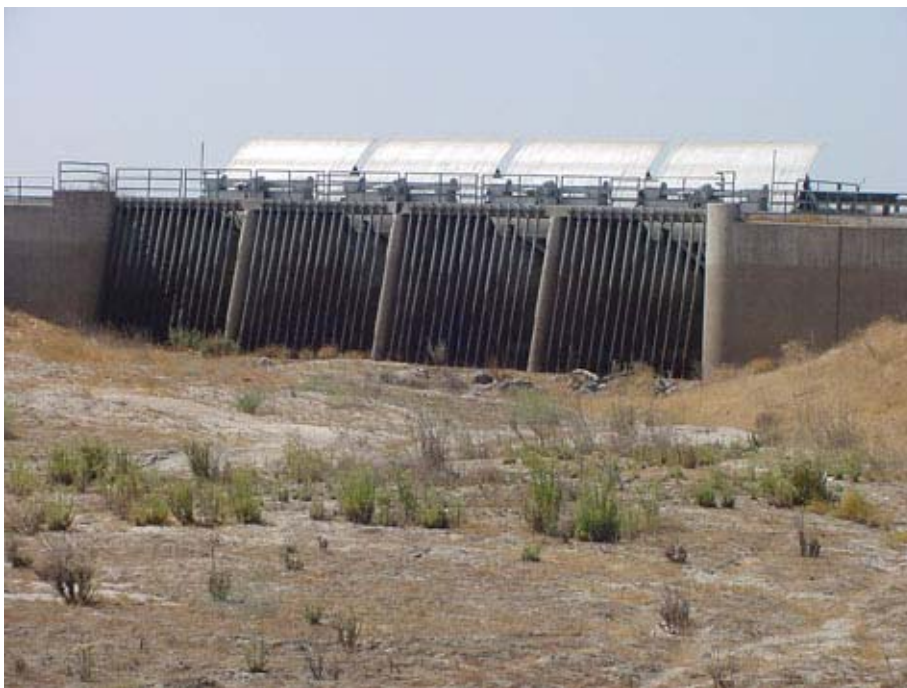
**The upstream side of the San Joaquin river structure.**

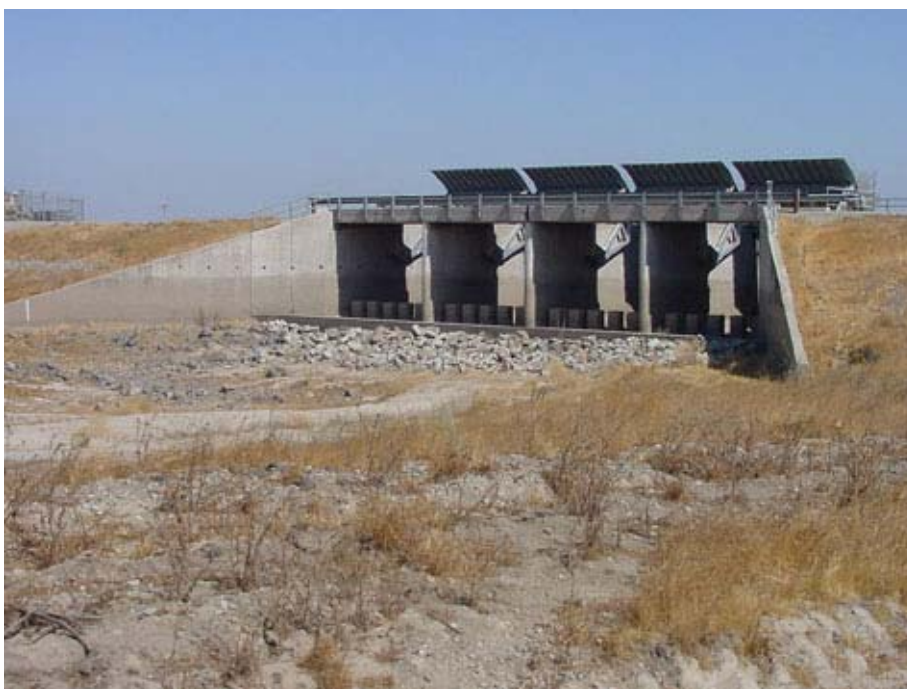
**The downstream at the San Joaquin river structure.**

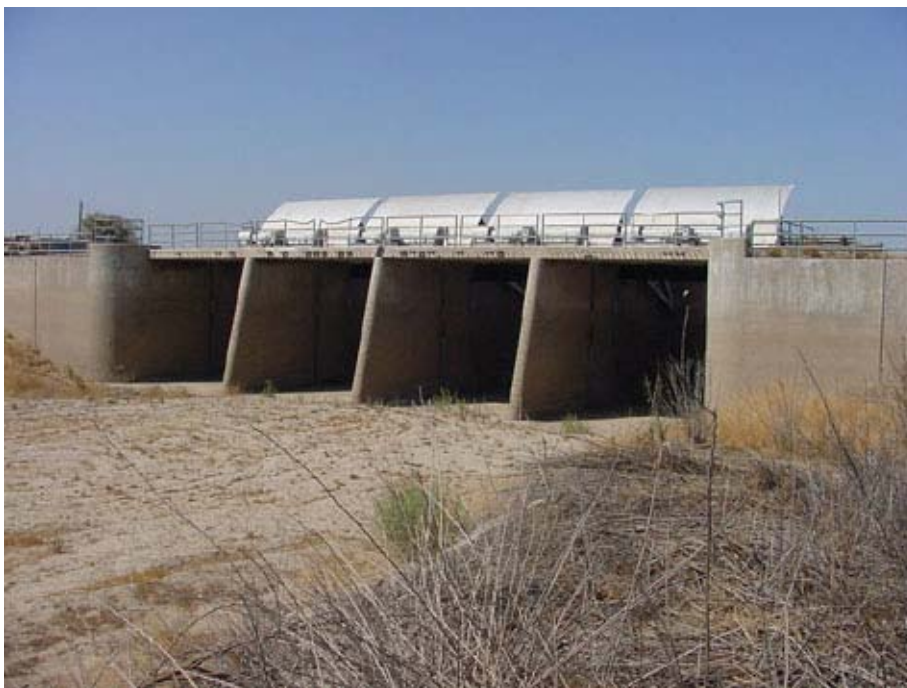
**The upstream side of the Chowchilla Canal bypass structure.**

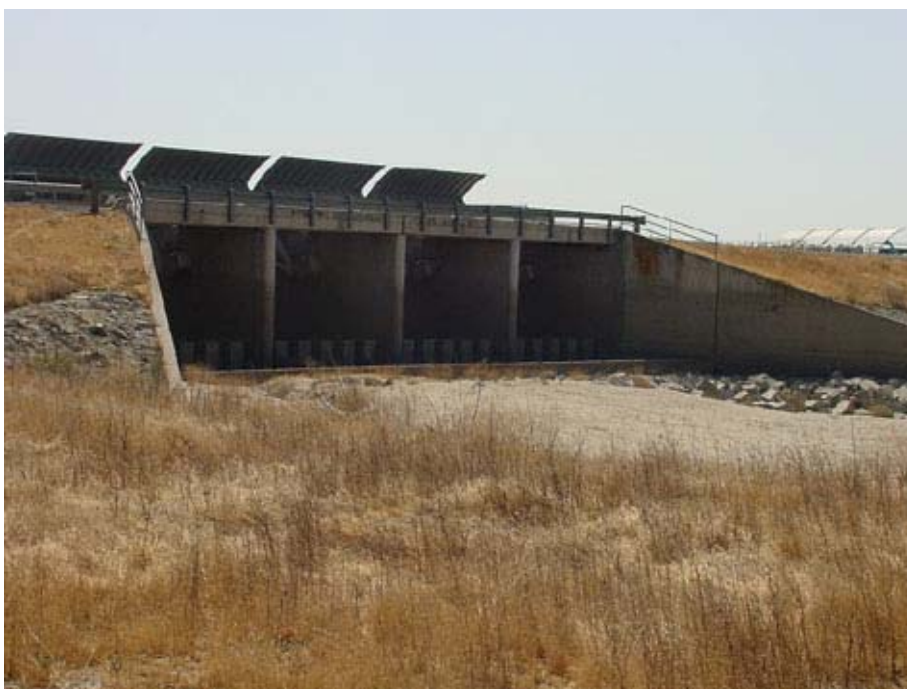
**The downstream side of the structure  
into the Chowchilla Canal bypass.**
